PROPERTY INSPECTION REPORT

Prepared For: John Smith
(Name of Client)

Concerning: 555 Exellent Inspection In., McKinney, TX 75070
(Address or Other Identification of Inspected Property)

By: Nicolas Thomas, Lic #20491 04/06/2017
(Name and License Number of Inspector) (Date)

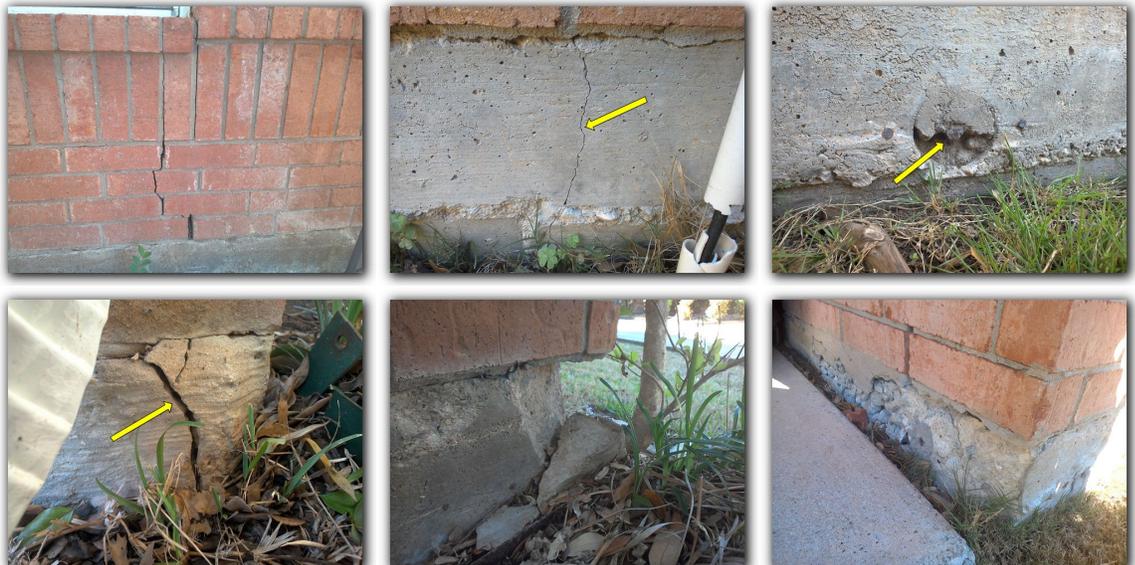
Foundation Needs Further Evaluation

The foundation appeared to have had movement that may be beyond normal. A Professional Engineer licensed by the State of Texas should be consulted on the current integrity of the foundation and any repairs that may be necessary (If Any). The observations made to support the rendering of this opinion are listed but not limited to the following:

- In my opinion, this foundation was showing signs of movement that may have exceeded normal tolerances.
- Deflection cracks were observed in the exterior veneer.

- Interior door(s) stick and/or not closing due to foundation movement.
- Stress crack(s) were observed in the exterior foundation perimeter beam.
- Interior sheetrock cracks and/or stress indicators.

- One or more of the post tension cable ends were exposed and need to be properly sealed on the north side(s) of the structure.
- A cracked corner cap was noted at the NW, SW, east corner(s) of the home. Although this is a cosmetic issue that does not adversely affect the performance of the foundation, repair is important. If not repaired, moisture can work its way to the reinforcement bars in the concrete. When that happens, it can become a structurally relevant issue. Additionally, if the caps fall off, brick veneer above the corners will start to sag with time.

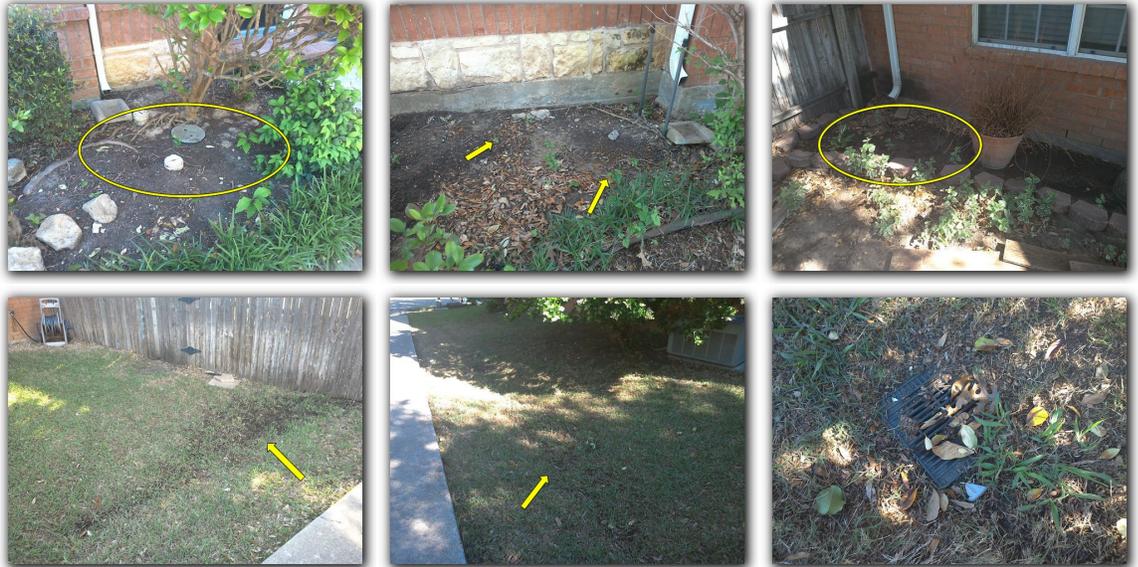
- Marginal site drainage was observed on the west, south, SE side(s) of the structure. Proper drainage is needed to help prevent water from standing and/or ponding next to the foundation beam. Corrective measures may be needed if the water stands within 10-feet of the foundation perimeter beam for more than 24-hours.
- **Notice:** There was an underground and/or surface drainage system in place. The inspector cannot and will not be able to verify the operation, sizing, efficiency or adequacy of the underground and/or surface drainage system. If there are any questions or concerns with this system or the effectiveness of the system, you should consult with the current homeowner or the appropriate specialist related to this type of system.

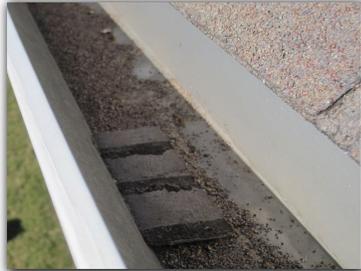
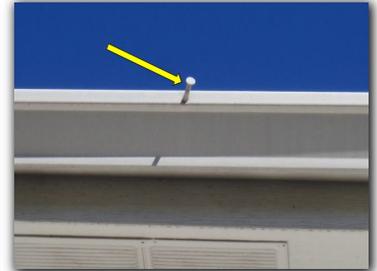
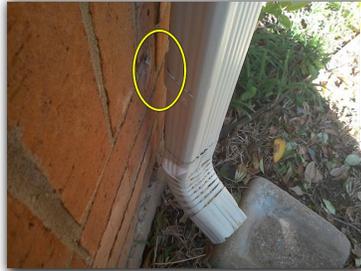
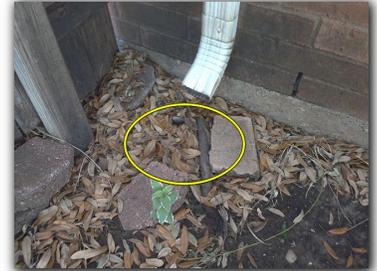
Gutter & Downspout System

- The gutters had some leaves and/or debris at a few spots across the home and require cleaning. Downspouts should also be checked to ensure that they are clear and flowing freely.
- One or more of the guttering fasteners were observed to be pulling loose on the east side(s) of the roof structure.
- Loose or damaged downspouts at the south, NW, north side(s) of the home should be repaired as necessary.
- Splash blocks should be installed at all downspout locations to prevent soil erosion near the foundation.

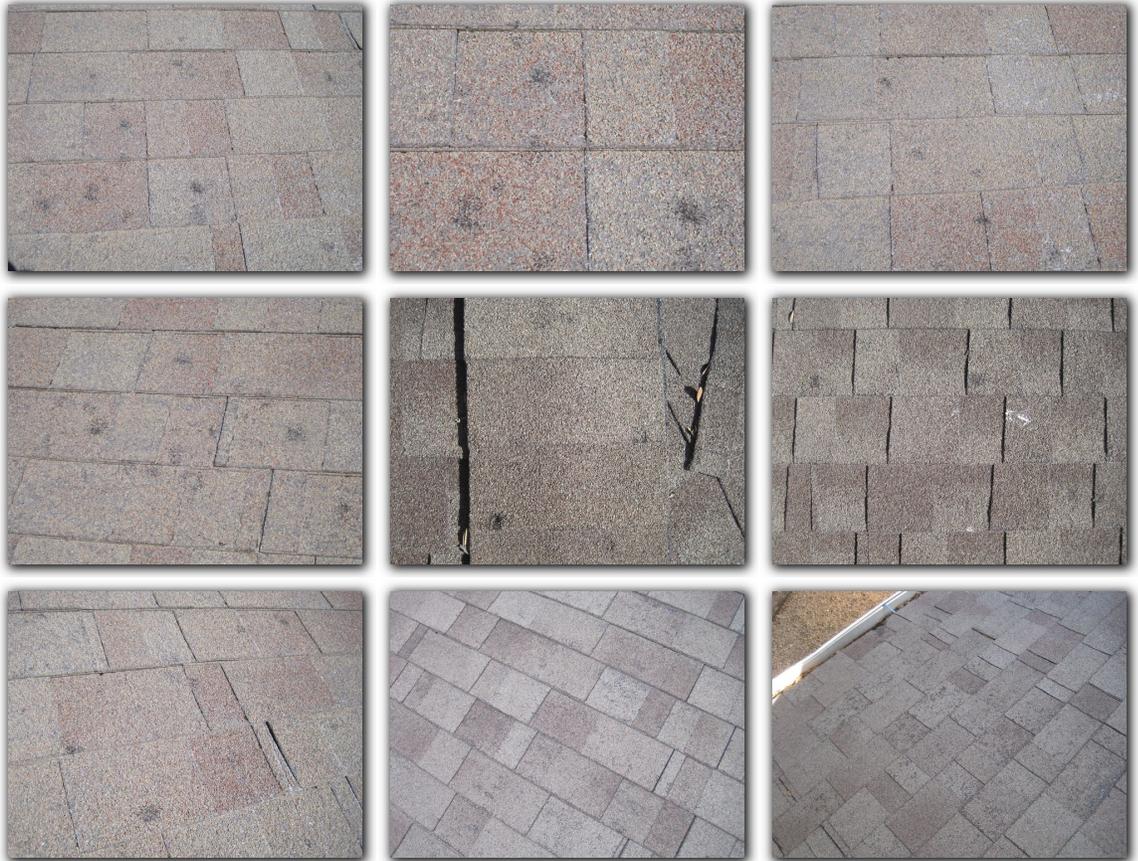
- The roofing material was observed to have impact damage in various locations. The impact damage may have been caused by a previous hailstorm and should be further evaluated.
- The composition roofing material had experienced considerable granular loss in various locations throughout the roof.
- Damaged shingles were observed on the west side(s) of the roof structure.
- **Note:** The tree and shrub branches should be trimmed away from the roofing material at all times.

You are encouraged to have a certified roofing contractor to physically inspect the roof, *prior to closing*, to fully evaluate the condition of the roofing material. The observation made to support the rendering of this opinion are listed but not limited to the following:

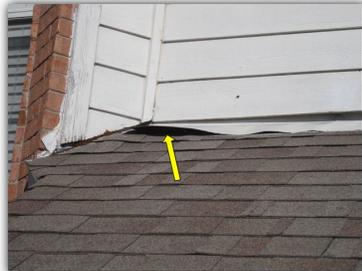
Flashing Details

- The flashing was lifting and/or pulling loose and should be re-secured on the east side(s) of the roof structure.

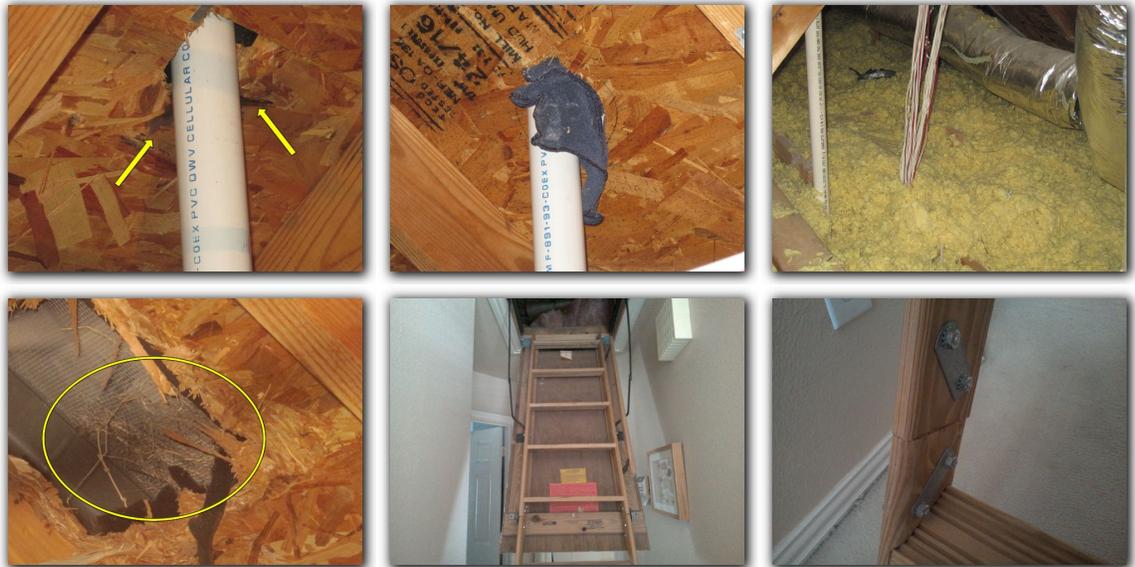
Attic Ladder(s)

- The attic access door was not properly insulated or weather stripped. Improve as necessary to prevent heating/cooling loss.
- Some of the attic ladder nuts and bolts were observed to be loose and/or missing. Minor improvements to the attic ladder are recommended for reasons of safety.

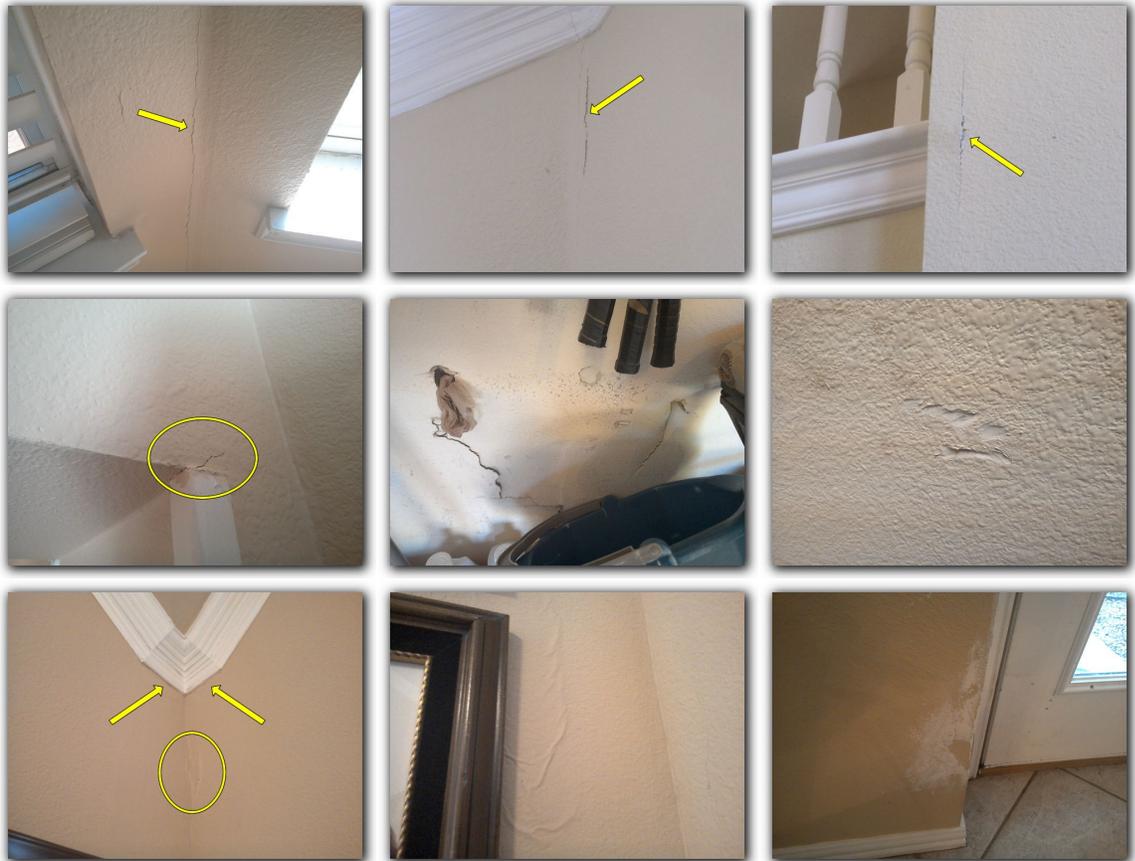
Interior Walls & Surfaces

- Interior wall joint cracks were observed in the master bedroom, front entrance area, upstairs bedroom hallway, upstairs side middle bedroom, gameroom
- Interior wall stress cracks were observed in the upstairs bedroom hallway.
- Wall surface damage was observed in the garage.
- The wall texture had some deterioration and/or damage in the master bedroom closet, study, stairwell area.
- Water damage was observed on the walls in the study. The cause and remedy should be further evaluated and corrected as necessary.
- **Note:** There was evidence of painting and patching to the interior finish and prior interior finish repairs at one or more locations across the structure.

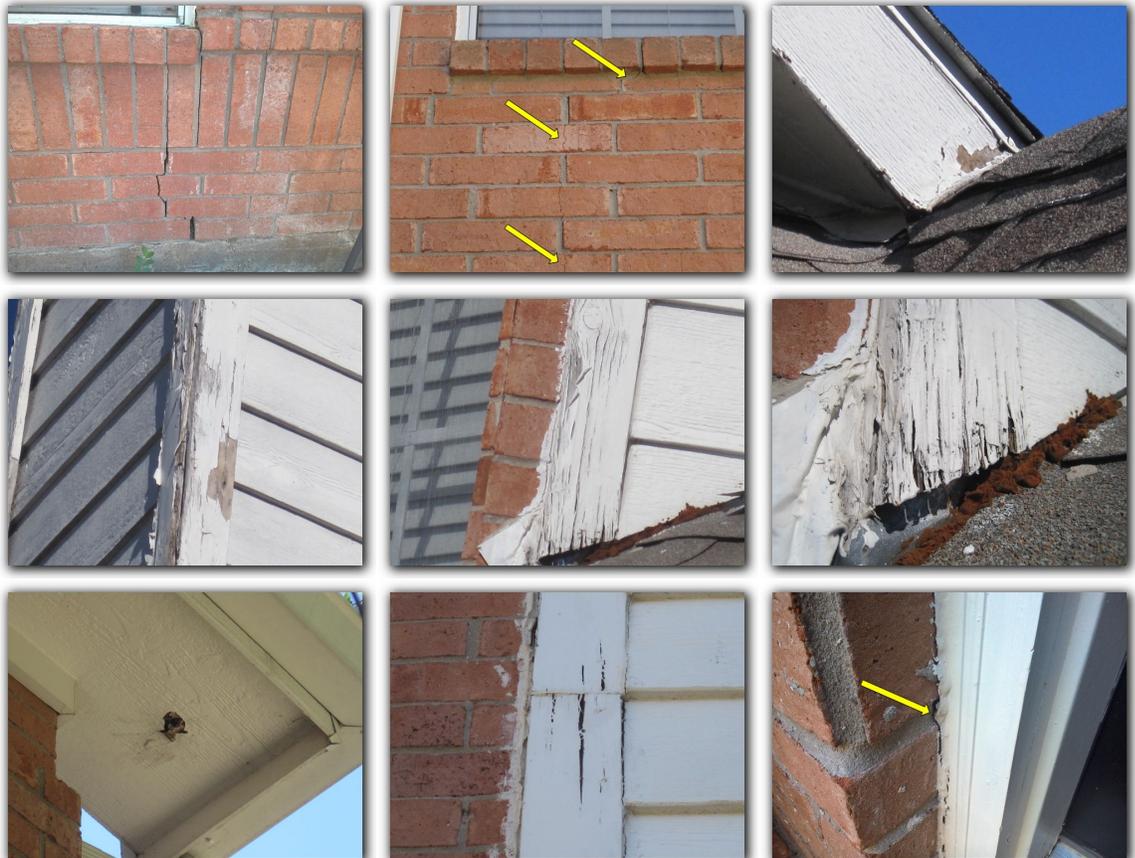
- Deflection cracks were observed in the exterior veneer on the west side(s) of the structure.
- Peeling and/or missing paint was noted at the fascia board, trim boards, chimney trim boards, soffit on the east side(s). Proper repair and repainting is recommended.

- Deterioration and wood rot was visible to the exterior door frame, trim boards, soffit on the east, west, south side(s). Proper repair and replacement of damaged material is needed.

- Caulking improvements are recommended for the area between the exterior veneer and the exterior door frames. It is recommended to use elastomeric caulking.

- Caulking improvements are recommended for the area between the exterior veneer and the window frames. It is recommended to use elastomeric caulking.
- Black algae staining was observed at the west exterior wall as a result of splash back from roof runoff. This is mostly a cosmetic concern that can be treated with an algaecide; however, this condition will reoccur if gutter are not installed to direct the flow of water off of the roof.

- The fascia board material had some deterioration and/or damage on the west side(s) of the roof structure.
- The soffit material had some deterioration and/or damage on the SW side(s) of the roof structure.

- **Note:** Minor mortar and/or brick cracks were observed in the exterior veneer wall.

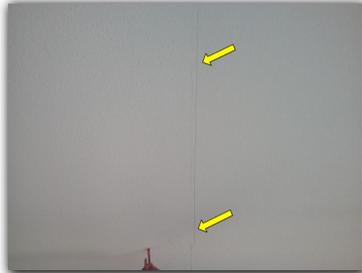
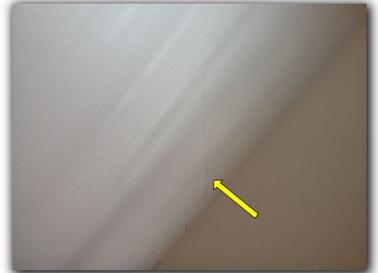
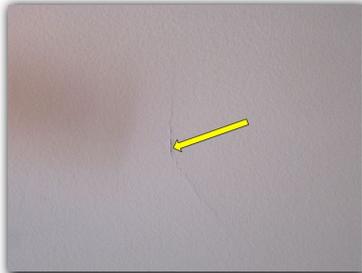
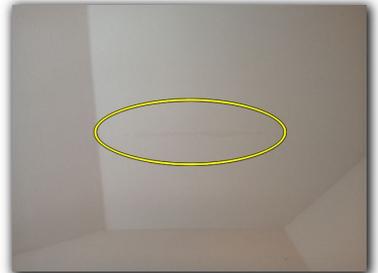
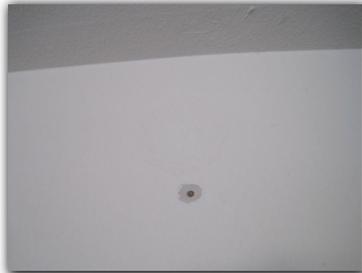
Ceilings

- Ceiling joint cracks were observed in the garage, upstairs bedroom hallway, gameroom.
- Ceiling stress cracks were observed in the upstairs side middle bedroom.
- Water stains were observed on the ceiling finish in the rear middle bedroom. The cause and remedy should be further evaluated and corrected as necessary.
- **Note:** Nail heads were observed to be pushing through the interior finish in one or more locations.

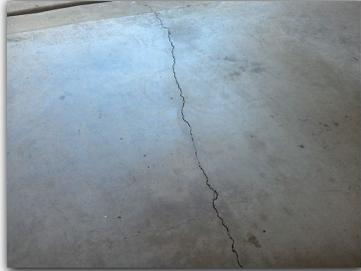
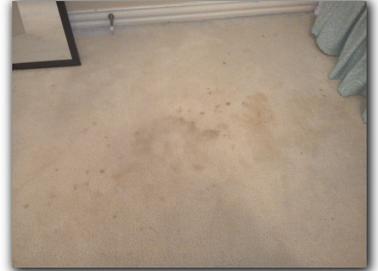
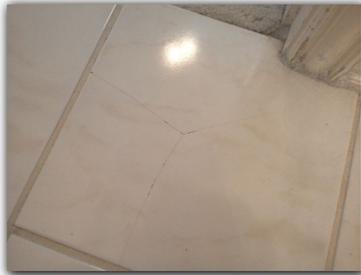
- Larger than typical cracks and/or deficiencies were observe in the garage floor.
- The floor covering was observed to be damaged in the master bedroom closet.
- The floor covering is noticeably stained in one or more locations of the home.
- The floor tile(s) were observed to be cracked and/or damaged in the Jack and Jill bathroom.

Note: The upstairs sub-floors (flooring) observed to squeak when walked over.

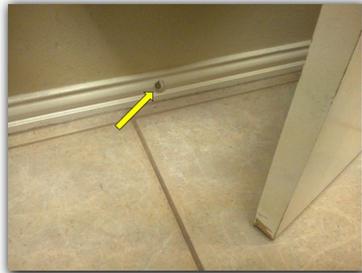
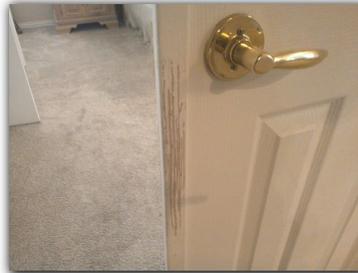
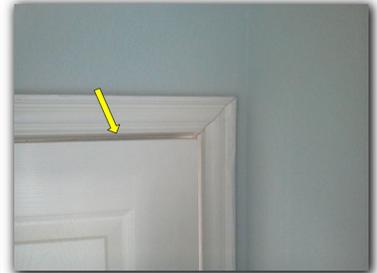
Interior Doors

- One or more of the door stoppers were damaged or missing.
- The door had some surface damage to the master bedroom.
- The door was sticking and would not close properly to the upstairs front corner bedroom.

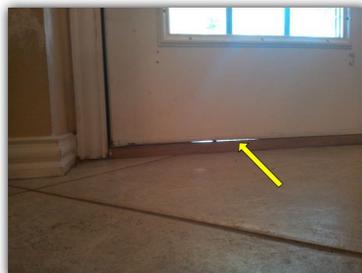
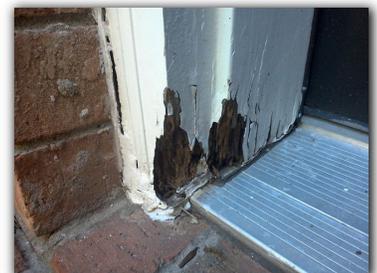
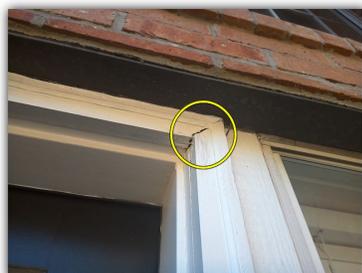
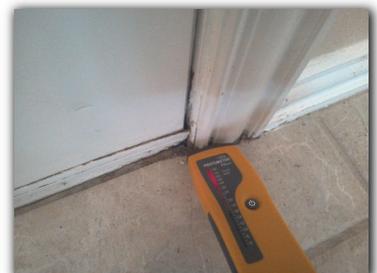
Exterior Doors

- Visible daylight was observed at the backyard entry door. Weather stripping improvements are needed to prevent heating /cooling loss and water / pest intrusion.
- Weather-stripping improvements were recommended for the exterior doors.
- The exterior door and frame had some deterioration and/or damage to the backyard entry, front entry door(s). Wood rot was visible and repairs are needed.
- Exposed wood (peeling paint or unpainted wood) was noted to the exterior threshold on the backyard entry door(s). These areas should be properly sealed and painted to prevent deterioration/damage.
- Visible evidence of previous water intrusion was observed at and/or around the exterior front entry door(s). The cause and remedy should be investigated and corrected as necessary.

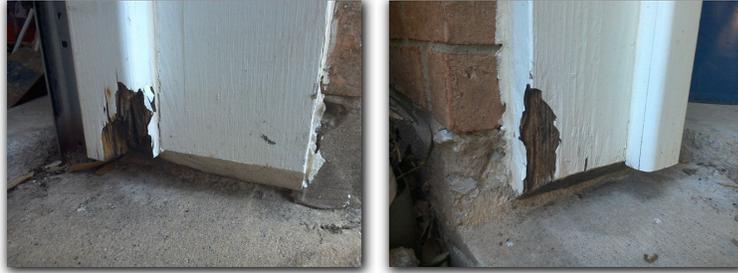
- The exterior overhead garage door frame had some deterioration and/or damage. Wood rot was visible and repairs are needed.
- Note: Regular service/maintenance is recommended for the garage door(s) and opener(s).

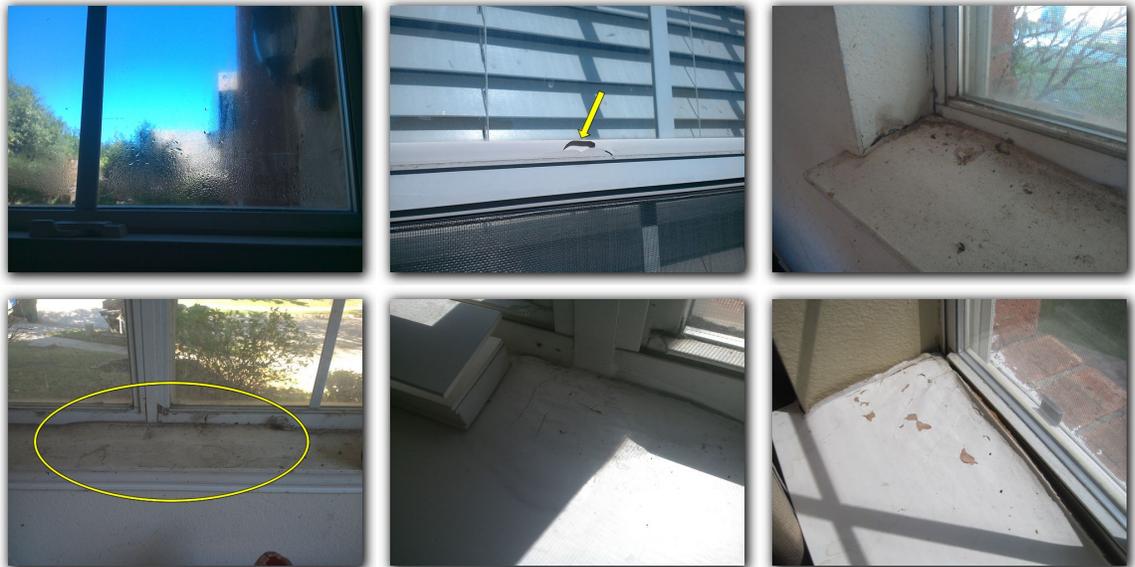
- Approximately 42 of the thermal pane windows were observed to have lost their seals. This has resulted in condensation or a fog like film to develop between the panes of glass or early indicators of mineral deposits. The thermal pane windows no longer function as designed when they loose their seal and replacement may be necessary. The windows that have noticeably lost their seals are listed but may not be limited to the following: family room, master bathroom, master bedroom, side middle bedroom, dining room, study, front entrance area, upstairs side middle bedroom, upstairs front corner bedroom, upstairs bedroom hallway, gameroom

- The window weather-stripping was damaged and/or missing at one or more of the windows and improvements are recommended.
- Visible evidence of water stains were observed at and/or around the window(s) in the garage, upstairs front corner bedroom. The cause and remedy should be investigated and corrected as necessary.
- Visible evidence of minor water damage was noted at various locations throughout the house window sill. Peeling paint and/or minor deterioration was visible. This may have been from condensation or previous water intrusion. Further evaluation is recommended.
- One or more of the windows were observed to be stiff and hard to operate in various locations throughout the house.

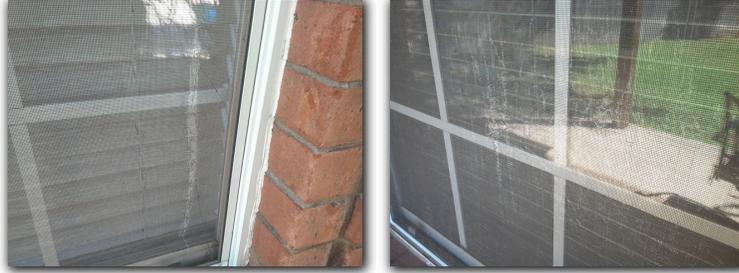
- One or more of the window screens were observed to be damaged.

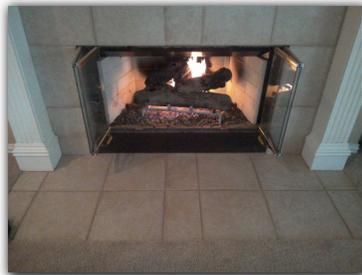
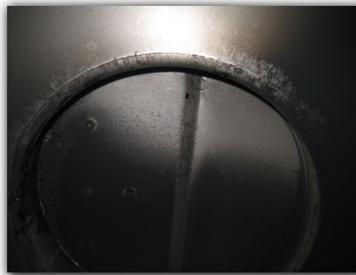
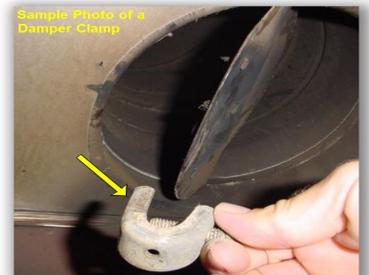
- **Note:** No damper clamp was visible on the damper. When artificial gas logs are installed in a firebox with a manual damper; it is recommended that the damper be permanently blocked open with a damper clamp to prevent accidental spillage of carbon monoxide into the living space.
- **Note:** There were gas logs installed in the firebox at the time of this inspection. I was unable to view the floor of the firebox at the time of this inspection.

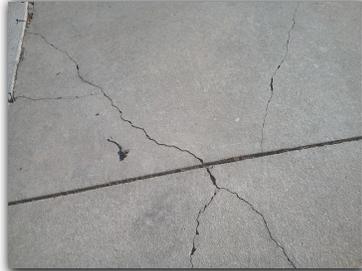
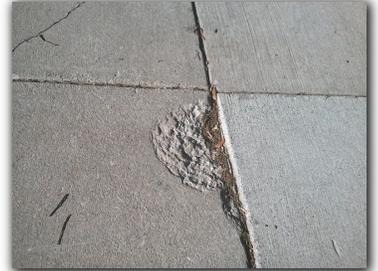
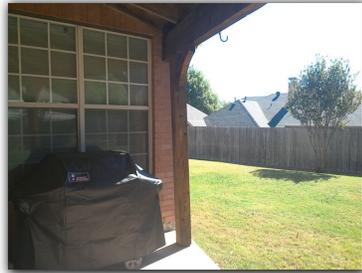
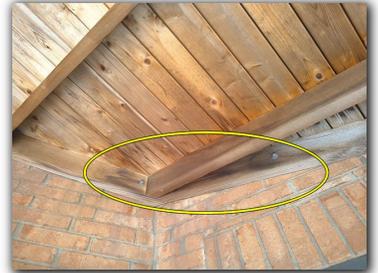
- Larger than typical cracks and/or deficiencies were observed in the driveway.
- One or more of the porch support posts was observed to be loose.
- The back porch concrete flatwork appeared to have settled more than normal.
- Some deflection and/or cracking of the patio concrete flatwork was observed.
- **Note:** There were visible water stains on the back porch cover decking and/or rafters in one or more locations.

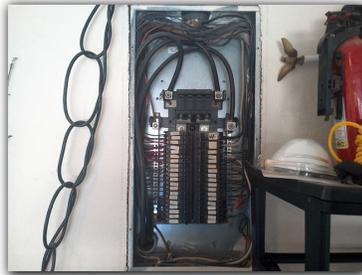
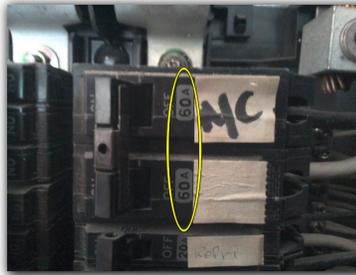
- One of the breakers for an AC unit was oversized. The manufacturers listing plate on the outside condenser/coil listed that the maximum over current device (breaker) to be used should not exceed 40-amp. There was a 60-amp breaker in place at the time of the inspection. Improper sizing of the AC breaker can affect performance and may void the AC manufacturer's warranty. Consult an electrician for panel evaluation and breaker replacement.

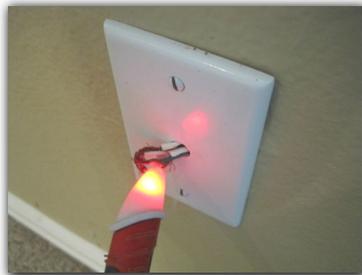
- Open end wires were observed in the family room. These should be properly capped and enclosed in a junction box.

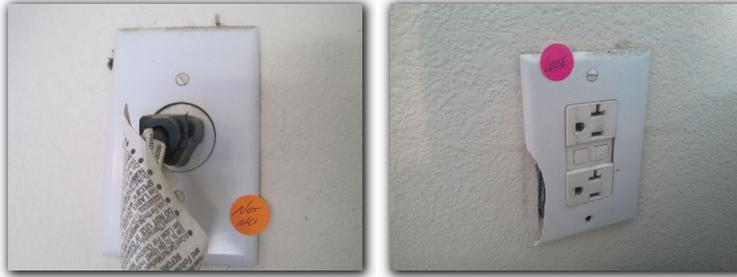
- Not all of the garage receptacles appeared to be connected to a ground fault circuit interrupter (GFCI) device. Under current electrical standards, all of the garage receptacles should have GFCI protection. There New 2008 National Electrical Code no longer has an exception for “non-appliance dedicated”.
- One or more of the receptacle cover plates were damaged in the garage.
- One or more of the receptacles were observed to be loose at the wall mount in the garage breakfast area, master bedroom closet.

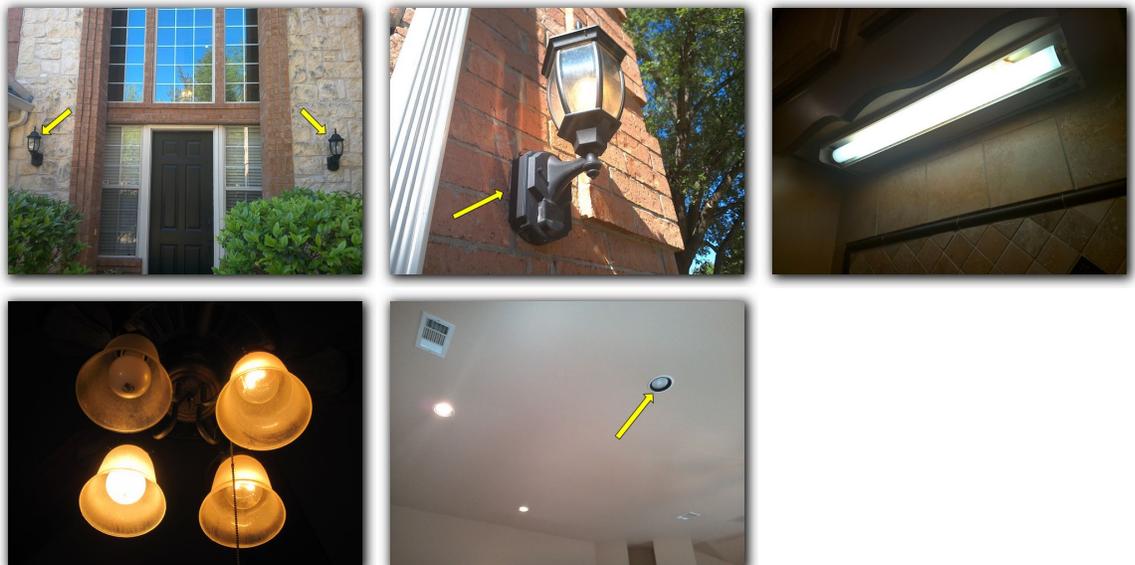
- One or more of the exterior light fixtures appeared to be inoperative at the front porch. This may be due to a bad or missing bulb, a photocell that could not be operated or some other unknown condition. These fixtures should be further evaluated and corrected as necessary.
- One or more of the light fixtures were loose at the wall/ceiling mount in the driveway.
- One or more of the light fixture globes and/or covers were damaged or missing in the kitchen.
- One or more of the light fixtures appeared to be inoperative at the study upstairs side middle bedroom gameroom. This may be due to a bad bulb or some other unknown condition. This condition should be further evaluated and corrected as necessary.

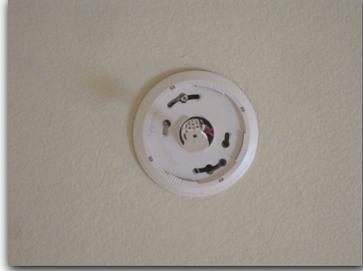
- One or more of the smoke alarms were missing in the upstairs side middle bedroom.

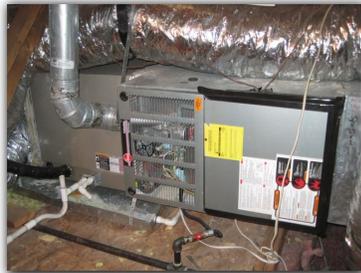
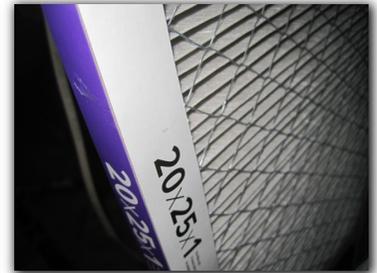
- The gas supply flex connector was observed to be passing through the heating unit cabinet. Under current mechanical installation standards, this is no longer an accepted practice. Only rigid black gas pipe is allowed to pass through the heating unit cabinet.

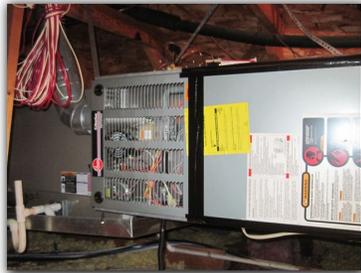
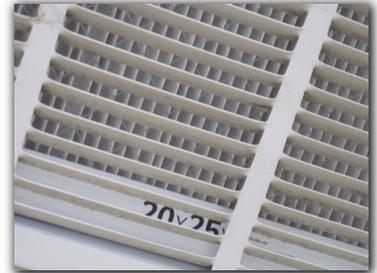
Unit #2: Upstairs Central Heating System

- The gas supply flex connector was observed to be passing through the heating unit cabinet. Under current mechanical installation standards, this is no longer an accepted practice. Only rigid black gas pipe is allowed to pass through the heating unit cabinet.

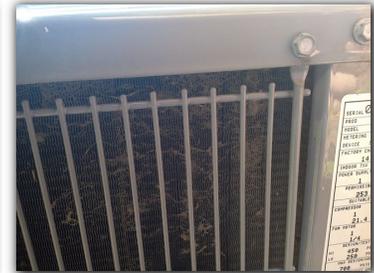
- The outdoor unit of the air conditioning system was out of level.
- Dirt/debris was visible at the fins of the outdoor condensing unit. Proper cleaning is needed.
- The manufacturers listing plate on the outside condenser/coil list that the maximum over current device (breaker) to be used should not exceed 40-amp. There was a 60-amp breaker in place at this time. This breaker in place did not meet the manufacturers listing plate requirements.
- **Note:** The auxiliary/secondary drain pan under the coil housing had some water staining and/or a rust build-up. This would indicate that the pan has held water in the past and should be closely monitored.

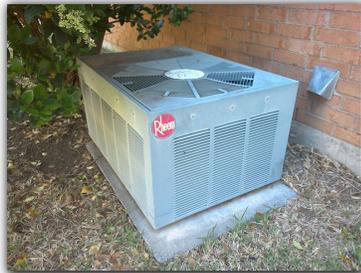
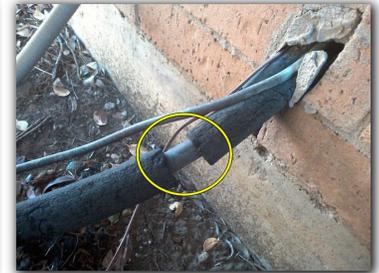
- Damaged, deteriorated and/or missing insulation on the refrigerant lines should be repaired or replaced at the outside condenser.

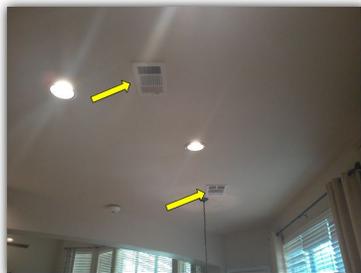
- An excessive variance in temperature was detected from one register to another. Although there can be differences in temperature from a register just off the unit versus the end of the service run, it is recommended that the ductwork be checked by a licensed HVAC technician to ensure that all lines are properly connected, unrestricted and in serviceable condition. Registers in question were located in the kitchen, breakfast area.

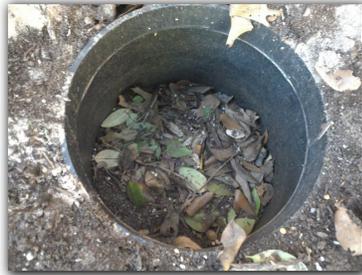
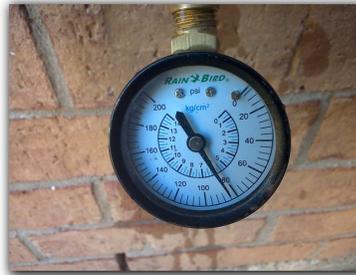
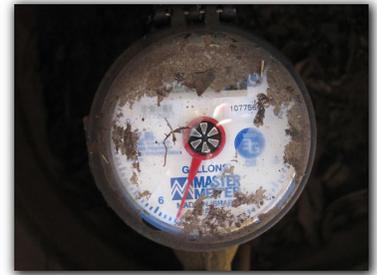
- The main water supply shutoff valve is covered in soil and was not inspected. The valve needs to be excavated for access.
- The water pressure was observed to be above 80 psi at the time of this inspection. Under current plumbing standards the maximum water pressure should be 80 psi. This condition should be further evaluated and corrected as necessary.

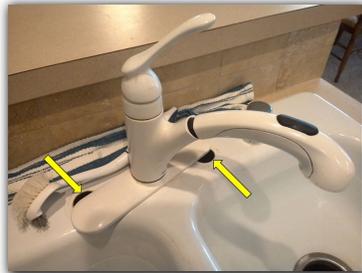
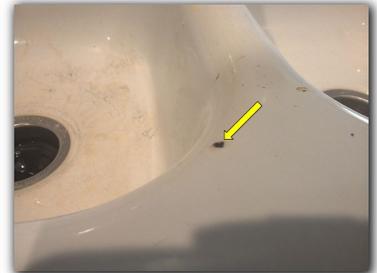
Sink (1)

- The faucet assembly was loose.
- Cracked/deteriorated or missing caulk/grout was visible at the sink backsplash.
- The sink had some surface damage.

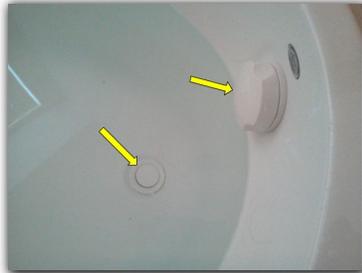
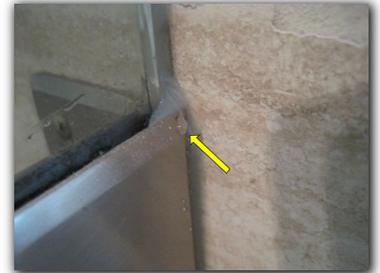
- The glass shower enclosure was observed to leak.

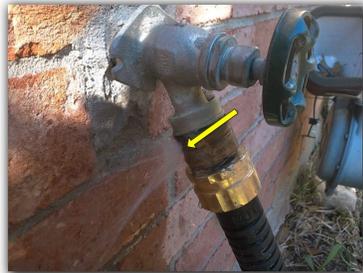
- Water was observed to be leaking back through the vacuum breaker on the north of the structure. The vacuum breaker was not working as designed.

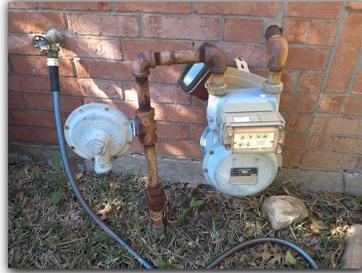
- **Note:** Rust was visible on the exterior natural gas piping. This is a natural occurrence based on the nature of the material, but preventative maintenance is recommended by removing surface rust and applying a protective coat of rust inhibiting paint.

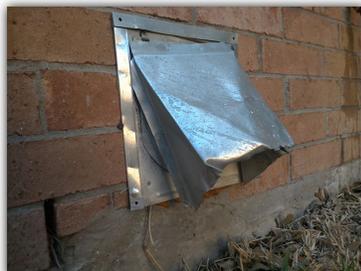
- The range exhaust vent exterior cover was damaged..
- The range exhaust vent filter was missing.

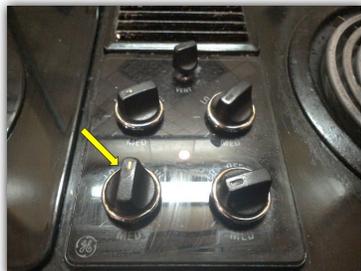
- One or more of the burners did not function properly and should be further evaluated.
- One or more of the burners was inoperative and should be further evaluated.

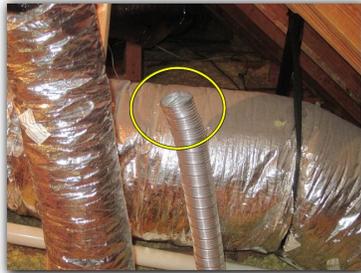
- The mechanical exhaust vents were observed to be venting into the attic area. Under current building standards, all mechanical exhaust vents should vent to the exterior of the structure. This is an “as-built” condition.

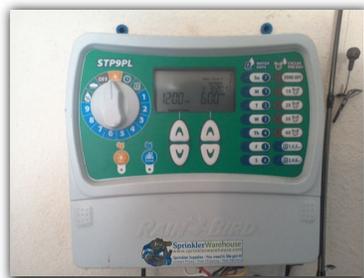
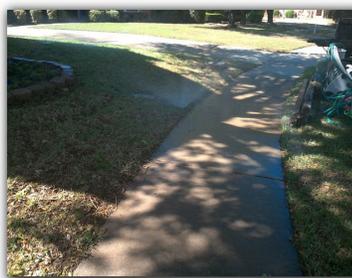
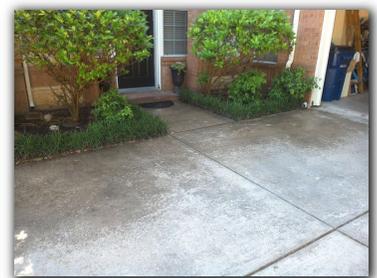
- I was unable to locate a moisture (rain / freeze) sensor device for the sprinkler system. This is an **“as-built” condition**, but Per TREC standards of practice we are required to report this condition as a deficiency.
