PROPERTY INSPECTION REPORT

Concerning: 1111 Address Dr., Navarre, FL 32566
(Address or Other Identification of Inspected Property)

By: Nicolas Thomas, Lic #HI13893 06/11/2021
(Name and License Number of Inspector) (Date)

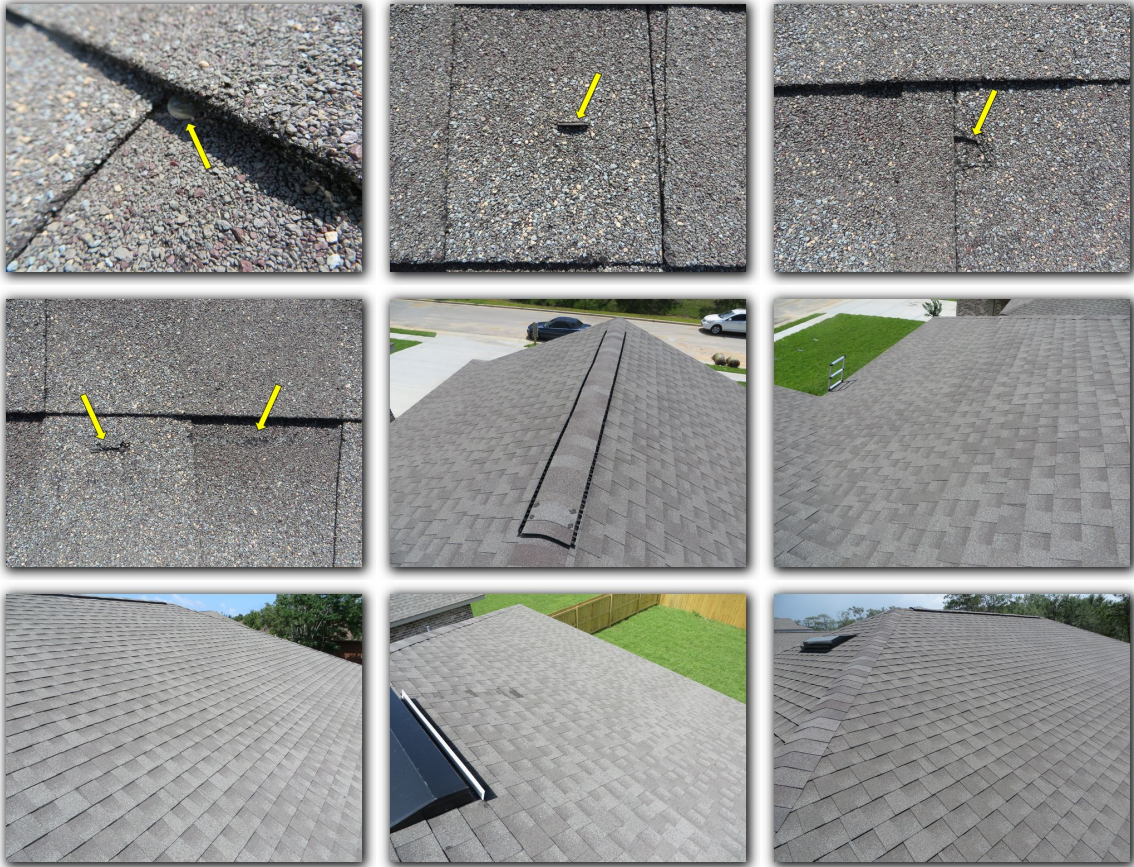
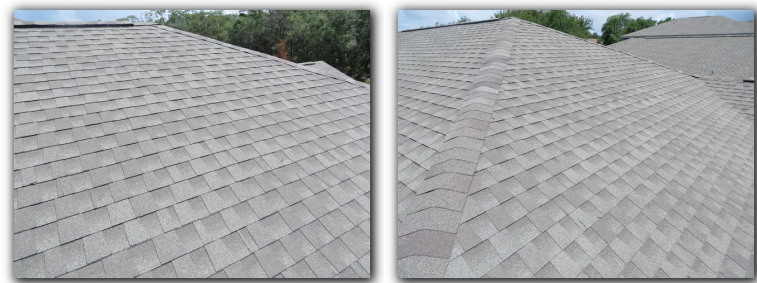
- The roof was in overall good condition but some minor repairs may be needed. You may wish to have a certified roofing contractor to physically inspect the roof, prior to closing, to fully evaluate the condition of the roofing material. The observation made to support the rendering of this opinion are listed but not limited to the following:
- Roof fasteners (nails and/or staples) were observed to be exposed and should be properly sealed at the ridge caps and flashing areas.
- Damaged shingles were observed on the west side(s) of the roof structure.

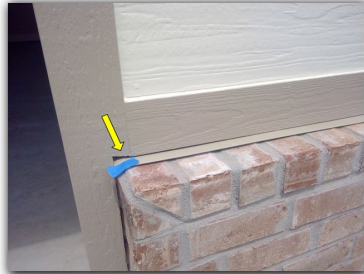
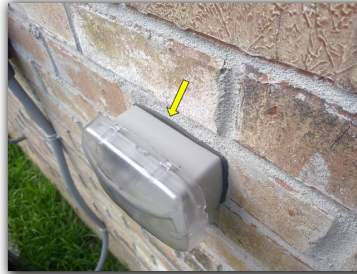
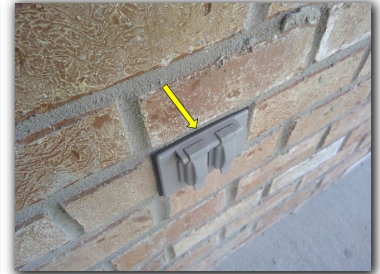
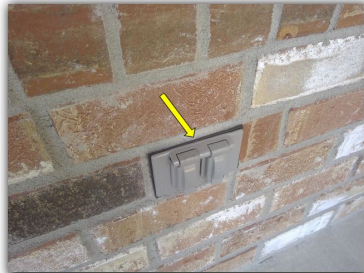
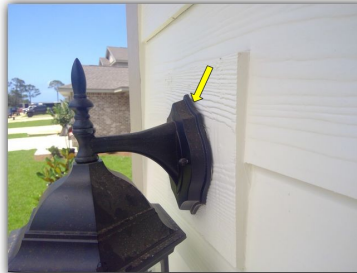
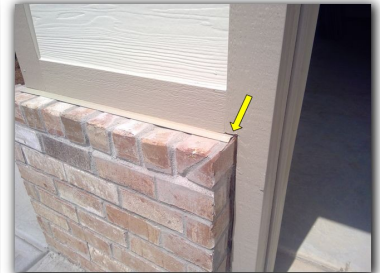
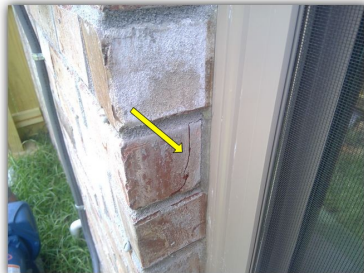
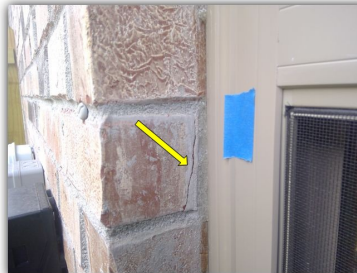
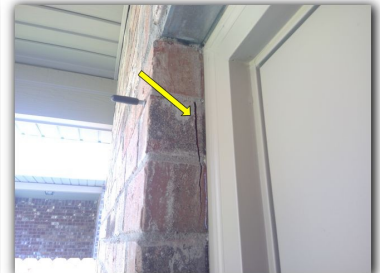
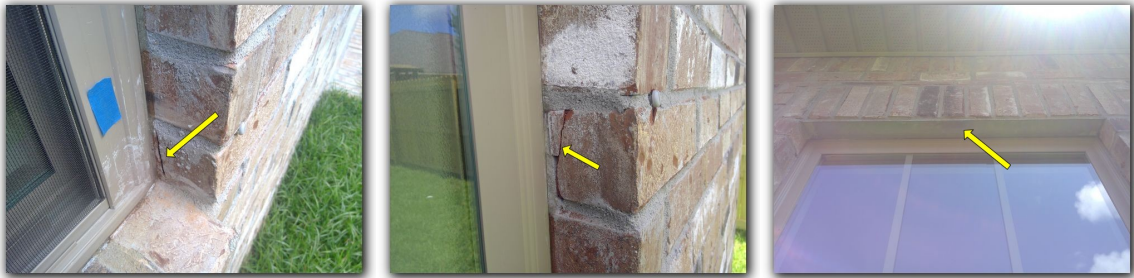
- All open joints and penetrations in the siding and/or siding trim boards need to be properly sealed to prevent water intrusion.
- The area between the exterior veneer and the exterior electrical outlet cover and/or light fixtures should be properly sealed to prevent water intrusion.
- Minor mortar and/or brick cracks were observed in the exterior veneer on the north, west side(s) of the structure.
- The steel lintels over the exterior doors and/or windows need to be painted.

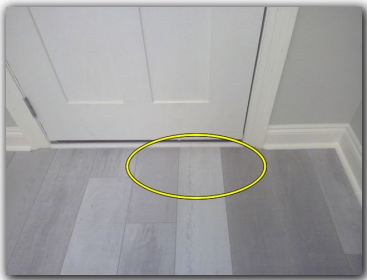
- The flooring was observed to squeak and deflect when walked over in the front entrance area.

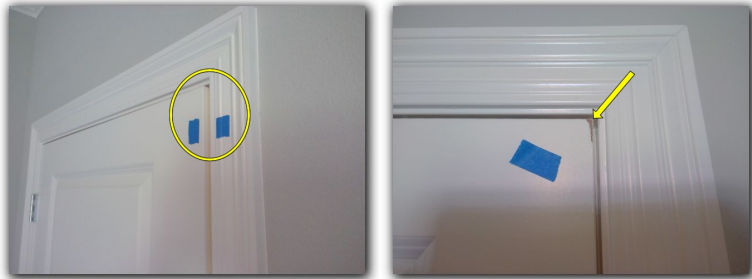
- The doors was out of square on not lined up properly when closed at the master bedroom.
- The door had some surface damage to the front corner bedroom closet.

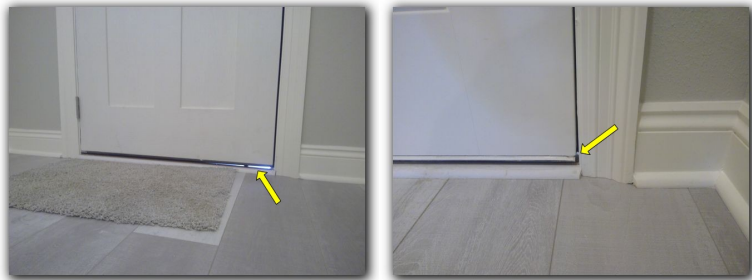
- Visible daylight was observed at the front entry, garage entry door. Weather stripping improvements are needed to prevent heating /cooling loss and water / pest intrusion.

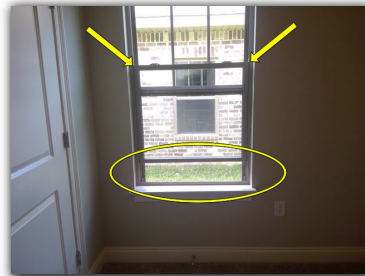
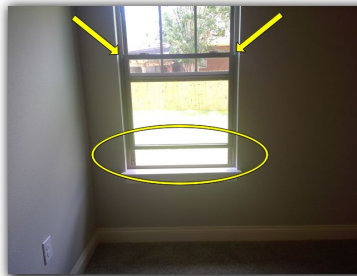
- One or more of the windows were observed to be stiff and hard to operate in the side middle bedroom, master bedroom.

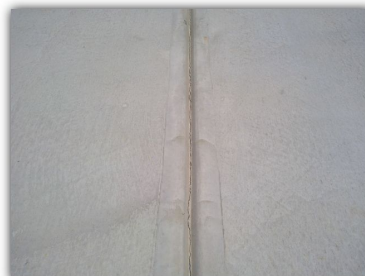
- Cracks and/or deficiencies were observed in the driveway.

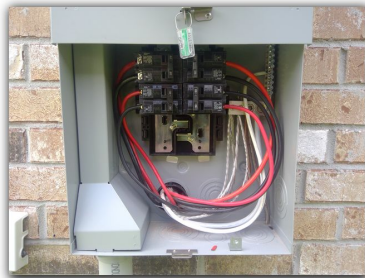
- *NOTE:* 80 amp service is considered marginal by modern standards and you may wish to consider upgrading for safety reasons.

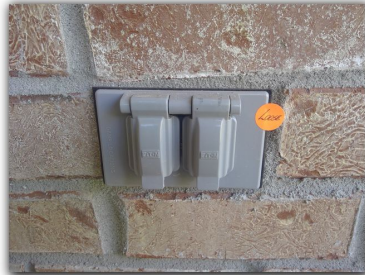
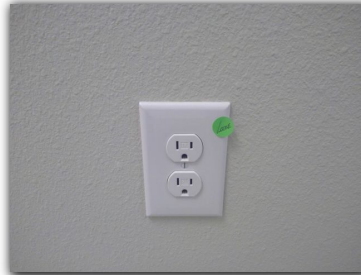
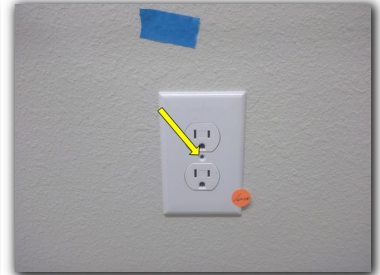
- One or more of the receptacles were observed to be loose at the wall mount in the back porch, front entrance area, family room, laundry room, kitchen island, master bedroom.
- One or more of the receptacles was missing its cover plate screw in the laundry room.

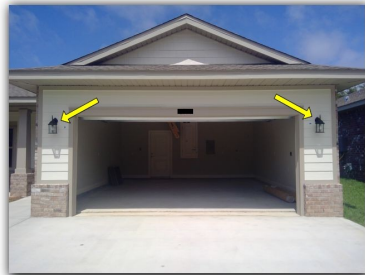
- One or more of the light fixtures were loose at the wall and/or ceiling mount in the driveway.

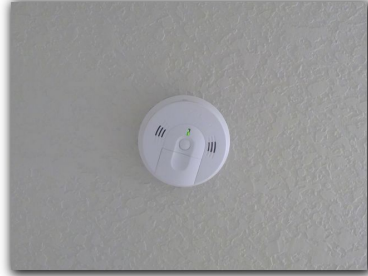
- Carbon Monoxide (CO) detectors were visible at one or more of the smoke detectors. CO detectors are recommended near sleeping areas, and on every level of the home. Detectors should not be placed within fifteen feet of heating or cooking appliances or in or near very humid areas such as bathrooms. Additional units may be needed.

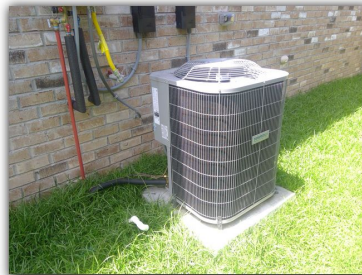
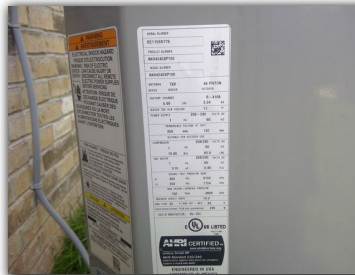
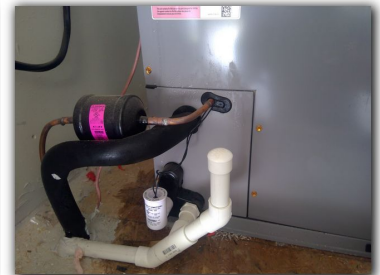
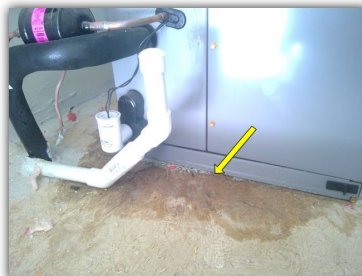
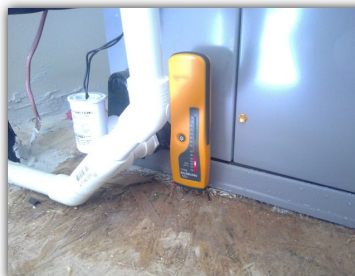
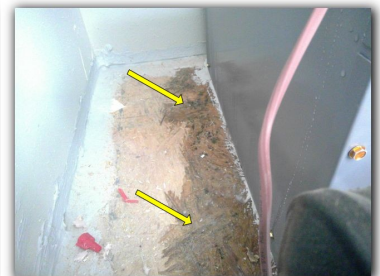
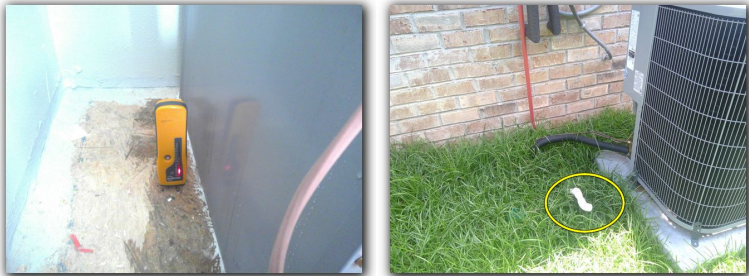
- The AC unit tonnage may be considered undersized for this square footage home (1763 sqft). The capacity of the air conditioning system may prove to be marginal during the warmer days of the summer. On older homes, the old rule of thumb was approximately 1 ton is required to cool 500 sqft. The AC unit tonnage sum equals 2 ton (appropriate for 1000 sqft). **However!** the sizing of an AC system no longer is measured by the square footage of the house, and without knowing the home RValue, performing detailed heat gain (Manual J) calculations, or living in the home during warm summer days, actual conditions are difficult to predict. Evaluation by a licensed HVAC technician is recommended.

- Condensation was observed around the coil housing. The cause and remedy should be further evaluated.
- Water stains were observed at the floor under or around the furnace/AC coils. Moisture was detected. This condition should be further evaluated and corrected as necessary.

- There was an unknown dark "organic growth like" observed in the furnace closet. Evaluation of this substance is beyond the scope of this inspection. If any concerns exist on the type and/or nature of this substance, we recommend further evaluation by a professional in the Air Quality sampling field.

- Note:** The primary condensate drain line was terminated next to the exterior foundation perimeter beam. It is recommended that the drain line terminate further away from the foundation beam or to an approved waste system.

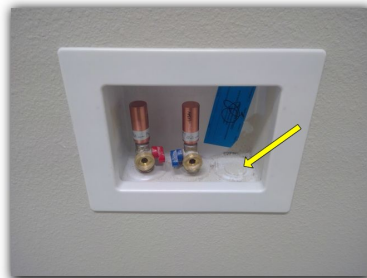
- The washing machine drain (receptor) was plugged and the drain was not visible. This should be further evaluated and corrected as necessary.

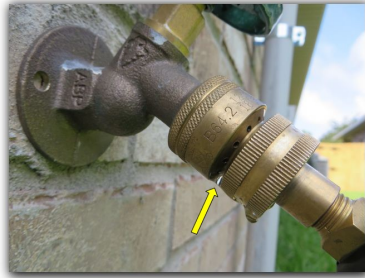
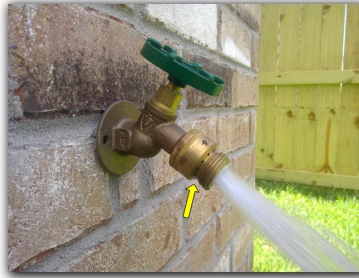
- Water was observed to be leaking back through the vacuum breaker on the NE of the structure. The vacuum breaker was not working as designed.

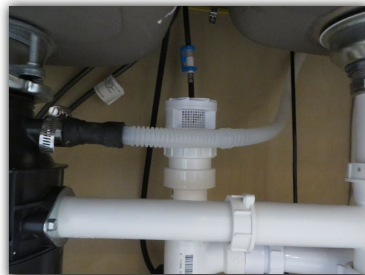
Note: The plumbing vent was vented beneath the kitchen sink. This vent installation is more common in commercial applications. If sewer odors are noticed, contact a licensed plumber as this usually suggests that the fixture is not properly vented, or that the trap has dried out.

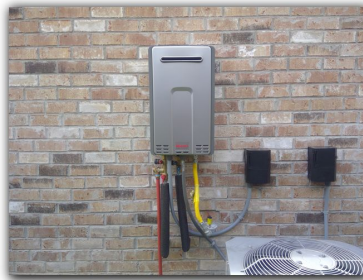
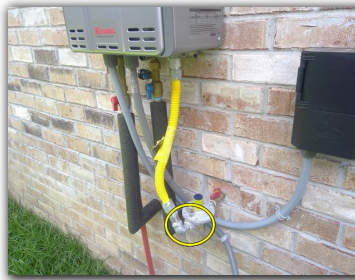
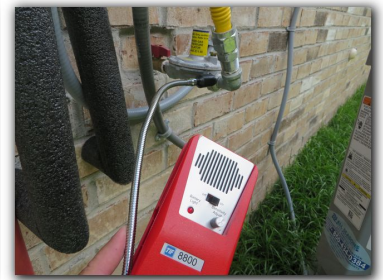
- There was a gas leak detected at or around the gas flex connector elbo. The inspector used a TIFF 8800 gas leak detector to locate the leak.

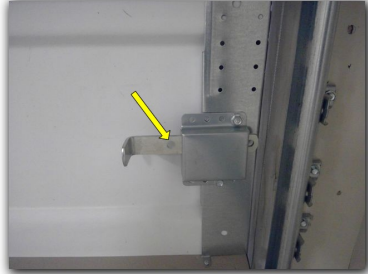
- When an automatic garage door opener is in use, the manual lock should be disabled.

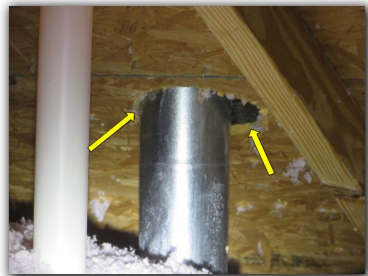
- The dryer duct termination was not properly sealed on the attic side of the roof structure penetration and was allowing dryer lint to fall back into the attic area.

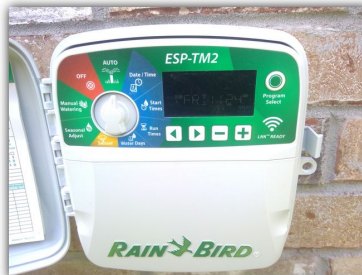
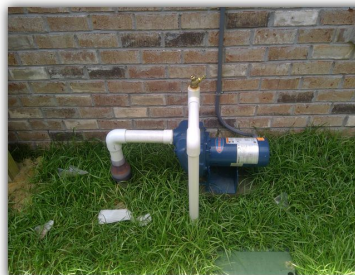
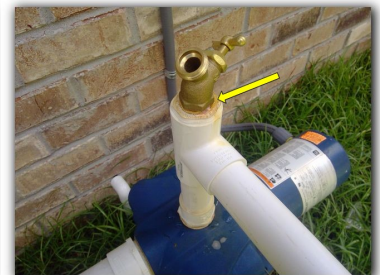
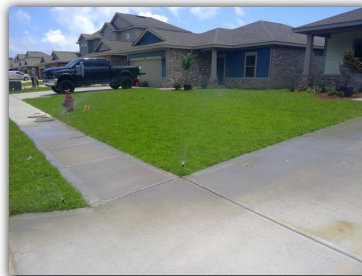
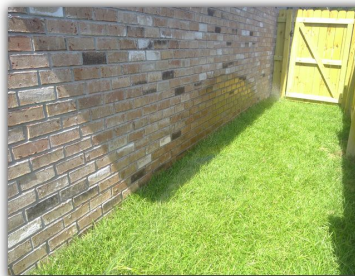
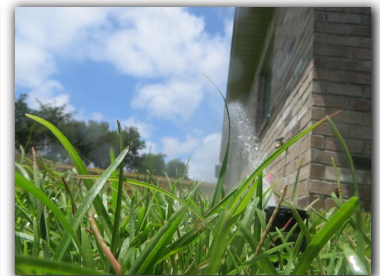
- One or more of the sprinkler heads need to be adjusted so not to disperse water onto concrete flatwork (such as; roadways, sidewalks, porches, patios or driveways) in station(s); **1**.
- One or more of the sprinkler heads need to be adjusted so not to spray water onto the exterior walls, surfaces and/or windows in stations; **1, 2**.
- The sprinkler pump leaked water at the faucet/purge connection when the sprinkler system was operated.
