PROPERTY INSPECTION REPORT

Prepared For: John Smith
(Name of Client)

Concerning: 555 Exellent Inspection In., McKinney, TX 75070
(Address or Other Identification of Inspected Property)

By: Nicolas Thomas, Lic #20491 04/06/2017
(Name and License Number of Inspector) (Date)

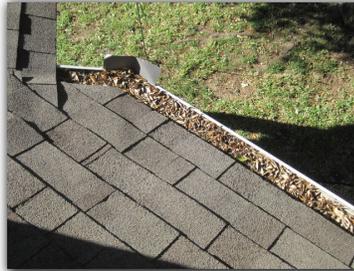
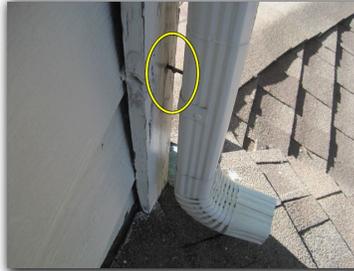
Gutter & Downspout System

- The gutters had some leaves and/or debris at a few spots across the home and require cleaning. Downspouts should also be checked to ensure that they are clear and flowing freely.
- One or more of the guttering fasteners were observed to be pulling loose on the east side(s) of the roof structure.
- Loose or damaged downspouts at the south, NW, north side(s) of the home should be repaired as necessary.
- Splash blocks should be installed at all downspout locations to prevent soil erosion near the foundation.

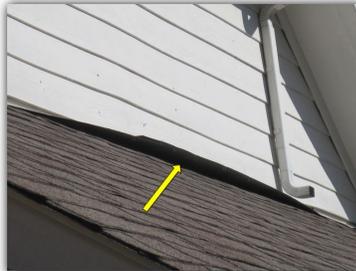
Flashing Details

- The flashing was lifting and/or pulling loose and should be re-secured on the east side(s) of the roof structure.

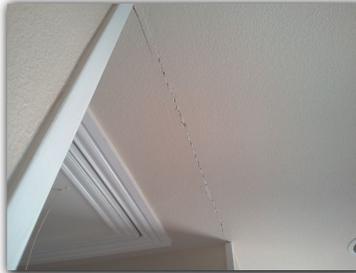
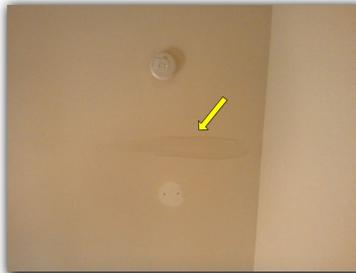
Ceilings

- Ceiling joint cracks were observed in the garage, upstairs bedroom hallway, gameroom.
- Ceiling stress cracks were observed in the upstairs side middle bedroom.
- Water stains were observed on the ceiling finish in the rear middle bedroom. The cause and remedy should be further evaluated and corrected as necessary.
- **Note:** Nail heads were observed to be pushing through the interior finish in one or more locations.

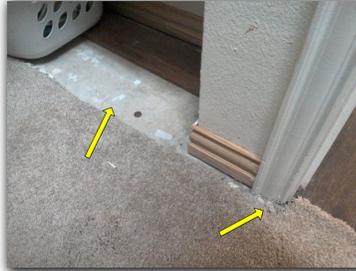
- Larger than typical cracks and/or deficiencies were observe in the garage floor.
- The floor covering was observed to be damaged in the master bedroom closet.
- The floor covering is noticeably stained in one or more locations of the home.
- The floor tile(s) were observed to be cracked and/or damaged in the Jack and Jill bathroom.

Note: The upstairs sub-floors (flooring) observed to squeak when walked over.

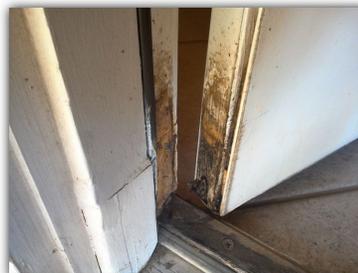
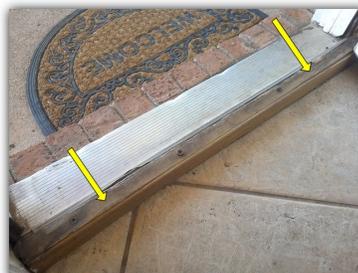
Exterior Doors

- Visible daylight was observed at the backyard entry door. Weather stripping improvements are needed to prevent heating /cooling loss and water / pest intrusion.
- Weather-stripping improvements were recommended for the exterior doors.
- The exterior door and frame had some deterioration and/or damage to the backyard entry, front entry door(s). Wood rot was visible and repairs are needed.
- Exposed wood (peeling paint or unpainted wood) was noted to the exterior threshold on the backyard entry door(s). These areas should be properly sealed and painted to prevent deterioration/damage.
- Visible evidence of previous water intrusion was observed at and/or around the exterior front entry door(s). The cause and remedy should be investigated and corrected as necessary.

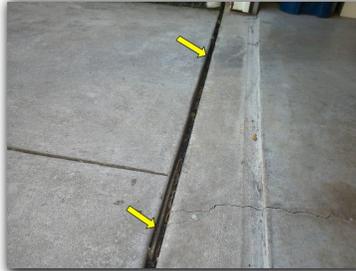
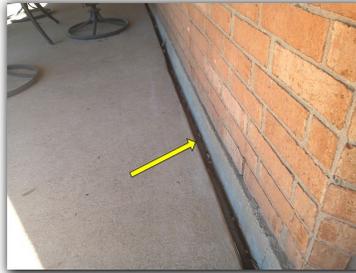
- Larger than typical cracks and/or deficiencies were observed in the driveway.
- One or more of the porch support posts was observed to be loose.
- The back porch concrete flatwork appeared to have settled more than normal.
- Some deflection and/or cracking of the patio concrete flatwork was observed.
- **Note:** There were visible water stains on the back porch cover decking and/or rafters in one or more locations.

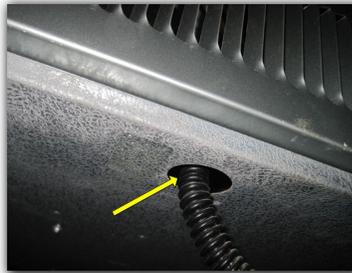
- The gas supply flex connector was observed to be passing through the heating unit cabinet. Under current mechanical installation standards, this is no longer an accepted practice. Only rigid black gas pipe is allowed to pass through the heating unit cabinet.

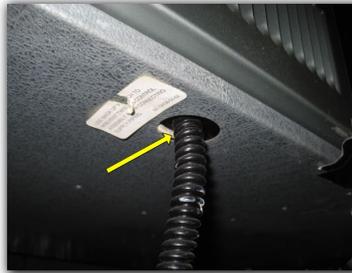
- The gas supply flex connector was observed to be passing through the heating unit cabinet. Under current mechanical installation standards, this is no longer an accepted practice. Only rigid black gas pipe is allowed to pass through the heating unit cabinet.

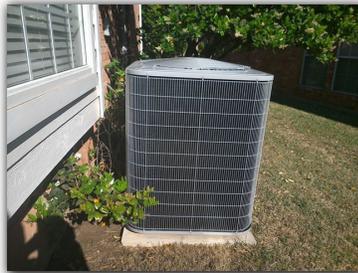
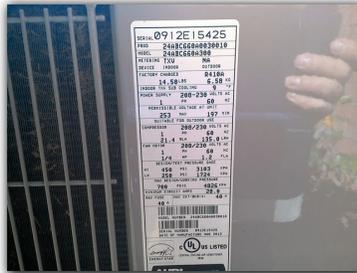
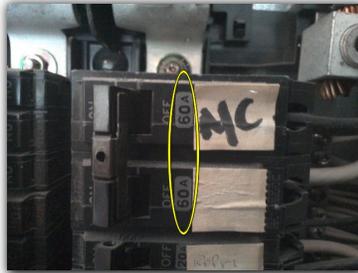
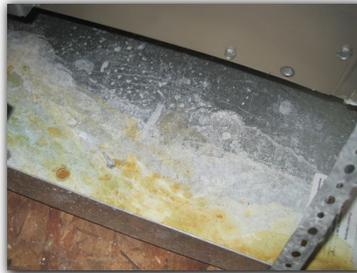
- The outdoor unit of the air conditioning system was out of level.
- Dirt/debris was visible at the fins of the outdoor condensing unit. Proper cleaning is needed.
- The manufacturers listing plate on the outside condenser/coil list that the maximum over current device (breaker) to be used should not exceed 40-amp. There was a 60-amp breaker in place at this time. This breaker in place did not meet the manufacturers listing plate requirements.
- **Note:** The auxiliary/secondary drain pan under the coil housing had some water staining and/or a rust build-up. This would indicate that the pan has held water in the past and should be closely monitored.

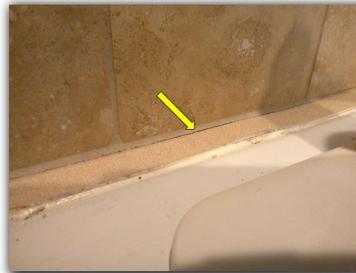
Sink (1)

- The faucet assembly was loose.
- Cracked/deteriorated or missing caulk/grout was visible at the sink backsplash.
- The sink had some surface damage.

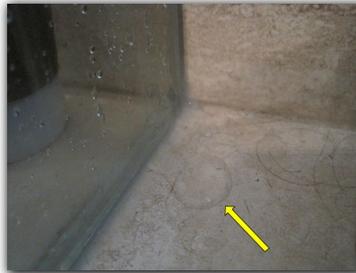
Enclosure:

- The glass shower enclosure was observed to leak.

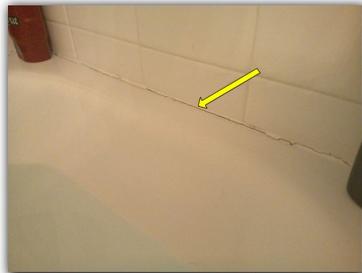
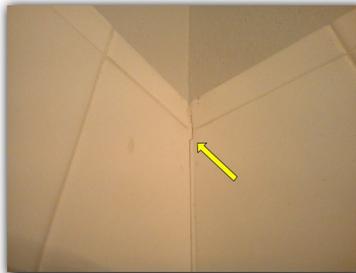
- Cracked, deteriorated and/or missing bathtub enclosure grout and/or caulking should be repaired or replaced as necessary.
- Cracked, deteriorated and/or missing shower stall grout and/or caulking should be repaired or replaced as necessary.

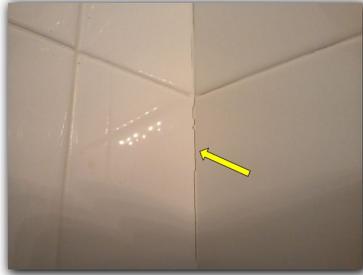
- Cracked, deteriorated and/or missing shower stall grout and/or caulking should be repaired or replaced as necessary.

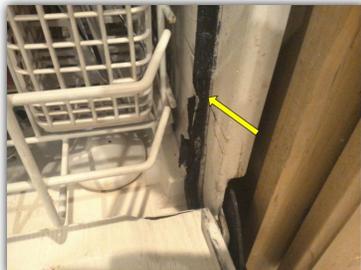
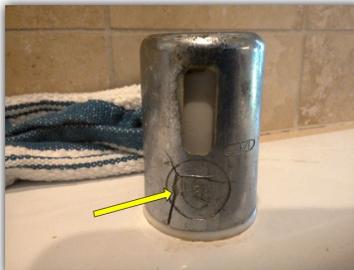
- Some damage to the dishwasher door seal was observed.
- The dishwasher air-gap device cap was damaged.

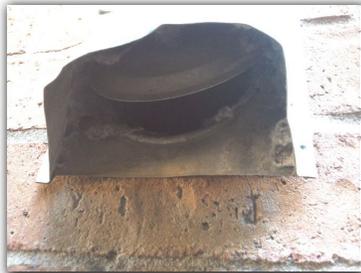
Vent Location: South Exterior Wall

- The damper was stuck in the open position. Lint should be cleared from the damper to allow it to close properly when not in use.

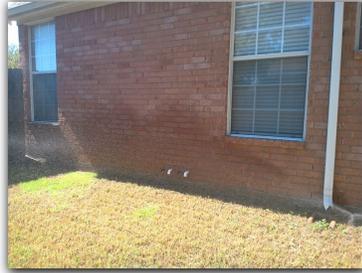
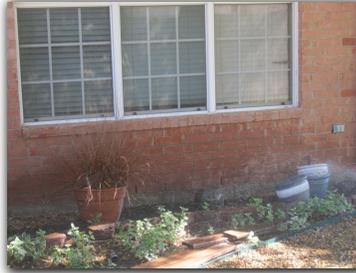
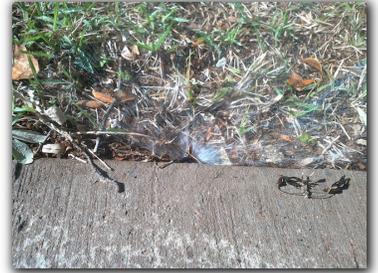
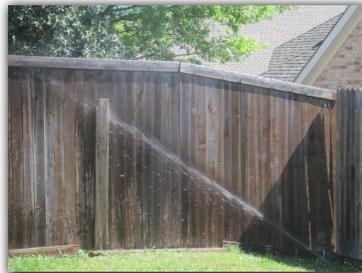
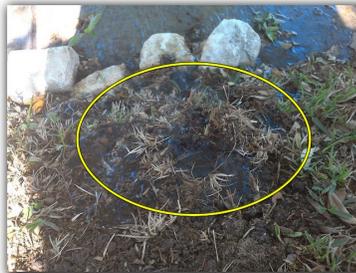
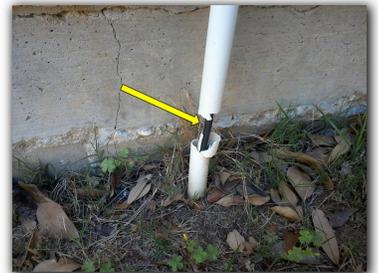
Sprinkler System and Associated Components Additional Comments or Pictures

- One or more of the sprinkler heads did not pop-up high enough to disperse water properly in station(s); **1.**
- One or more of the sprinkler heads appeared to be leaking at the base of the head in station(s); **1.** The cause and remedy should be further evaluated and corrected as necessary.

- One or more of the sprinkler heads need to be adjusted and/or straightened so to disperse water properly in station(s); **3, 5.**
- One or more of the sprinkler heads were observed to be damaged and/or missing in station(s); **6.**

- Low water pressure was observed in stations; **6.** The cause and remedy should be further evaluated and corrected as necessary.
- The conduit that is protecting the sprinkler system wires was damaged.

- I was unable to locate a moisture (rain / freeze) sensor device for the sprinkler system. This is an **“as-built” condition**, but Per TREC standards of practice we are required to report this condition as a deficiency.
