PROPERTY INSPECTION REPORT

Concerning: 1111 Address Dr., Navarre, FL 32566
(Address or Other Identification of Inspected Property)

By: Nicolas Thomas, Lic #HI13893 06/11/2021
(Name and License Number of Inspector) (Date)

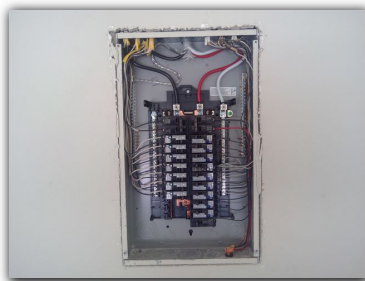
Box Location: Garage

All components were found to be performing and in satisfactory condition on the day of the inspection.

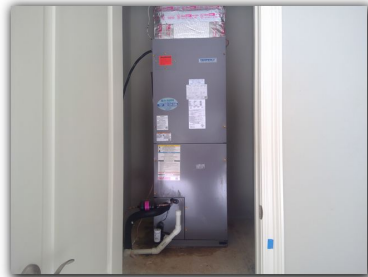
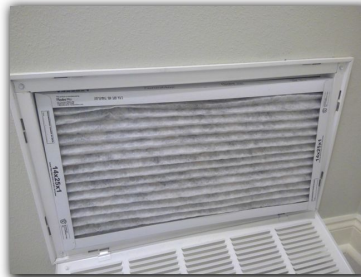
This component appeared to be performing adequately at the time of this inspection. It was achieving an operation, function, or configuration consistent with accepted industry practices for its age.

- Note: The heat pump was not operated in the heat pump mode at the time of the inspection. Operating the heat pump above 70 degrees (f) can damage the unit.**

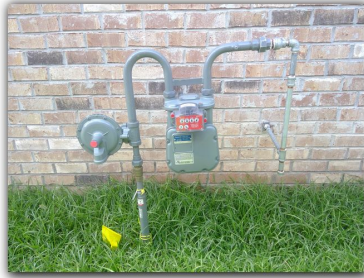
Gas Meter Location: north

This component appeared to be performing adequately at the time of this inspection.
